## Rocky Road to the Concours

C/D's Maserati turns out to be a lady in need of rehabilitation

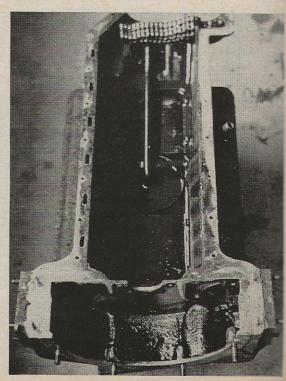
Sump was littered with tiny metal chips.

All journals on the seven-mainbearing crank are scored, most of them lightly, and the source of the metal fragments responsible was readily pointed out—the timing chains to the single overhead camshaft were so loose and floppy that they had rubbed great graunching grooves in the soft aluminum case; a grand argument for an oil filter.

The grooves themselves aren't important, and new chains and sprockets will be easy to find, since standards for them are international. But new babbitt must be poured in each bearing shell, then the mains will be line-bored, the crank journals will be polished (and some of them reground .010-inch undersize).

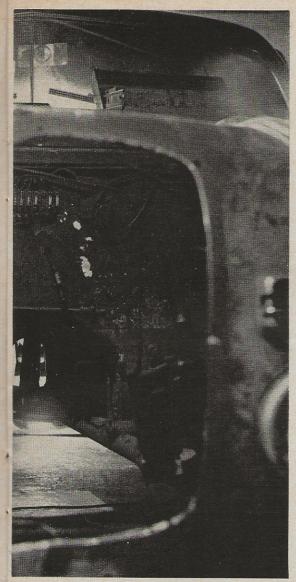
Engineless, the Maserati gapes vacantly.

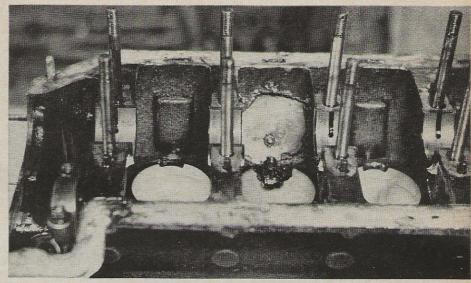
Gouged bottom of number-two cylinder and patched crankcase wall tell a sad tale.

Number-two piston's short skirt and missing bottom ring reveal makeshift repair.

If the engine is run this way for long, the liner can easily be broken. To our dismay, Charles Stich pointed to the adjacent cylinder where this had not only already happened, knocking off roughly a square inch of cylinder wall, but bringing down on the then-owner's head a horrible heap of troubles. A carefully welded-in patch in the aluminum crankcase alongside testified mutely that the number-two connecting rod

had committed the great, unpardonable sin. Confirming this, the number-two piston has one fewer oil ring than its mates and a shorter skirt (which can't have helped the balance very much). Also, that rod's flanks have none of the hammer-like marks that defile the other five.

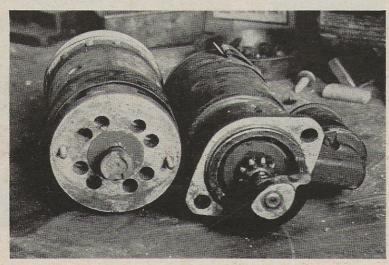
The lobes on the cam are in "iffy" condition, some of the metal bits having passed that way. They will merely be polished off, since this is not a project to revive every last bhp. The tongue-like followers need regrinding but pose no problem. The starter's Bendix gear was half worn away-she must have been a temperamental devil to start-and the generator's dog-drive to the water pump is so worn that Mr. Stich suspects it often abandoned the cooling system to the thermosiphon system, a not-so-good thing for our jewel. The clutch was like new—the reason being obvious when we saw all the blue stains of over-heating on the flywheel. An axle seal needs replacement on the left rear, and perhaps the shocks need replacement.

Teeth of starter's Bendix gear have been more than half worn away.

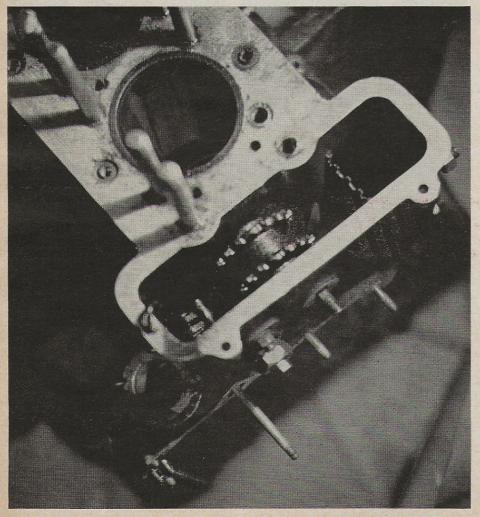
Loosened timing chains have chopped their own grooves into the aluminum casing.
