MAINTENANCE AND SERVICE NOTES

MERCEDES-BENZ 300Sc

MAINTENANCE AND SERVICE NOTES OF A LIFETIME ENJOYING THE 1956 MERCEDES-BENZ 300SC CABRIOLET

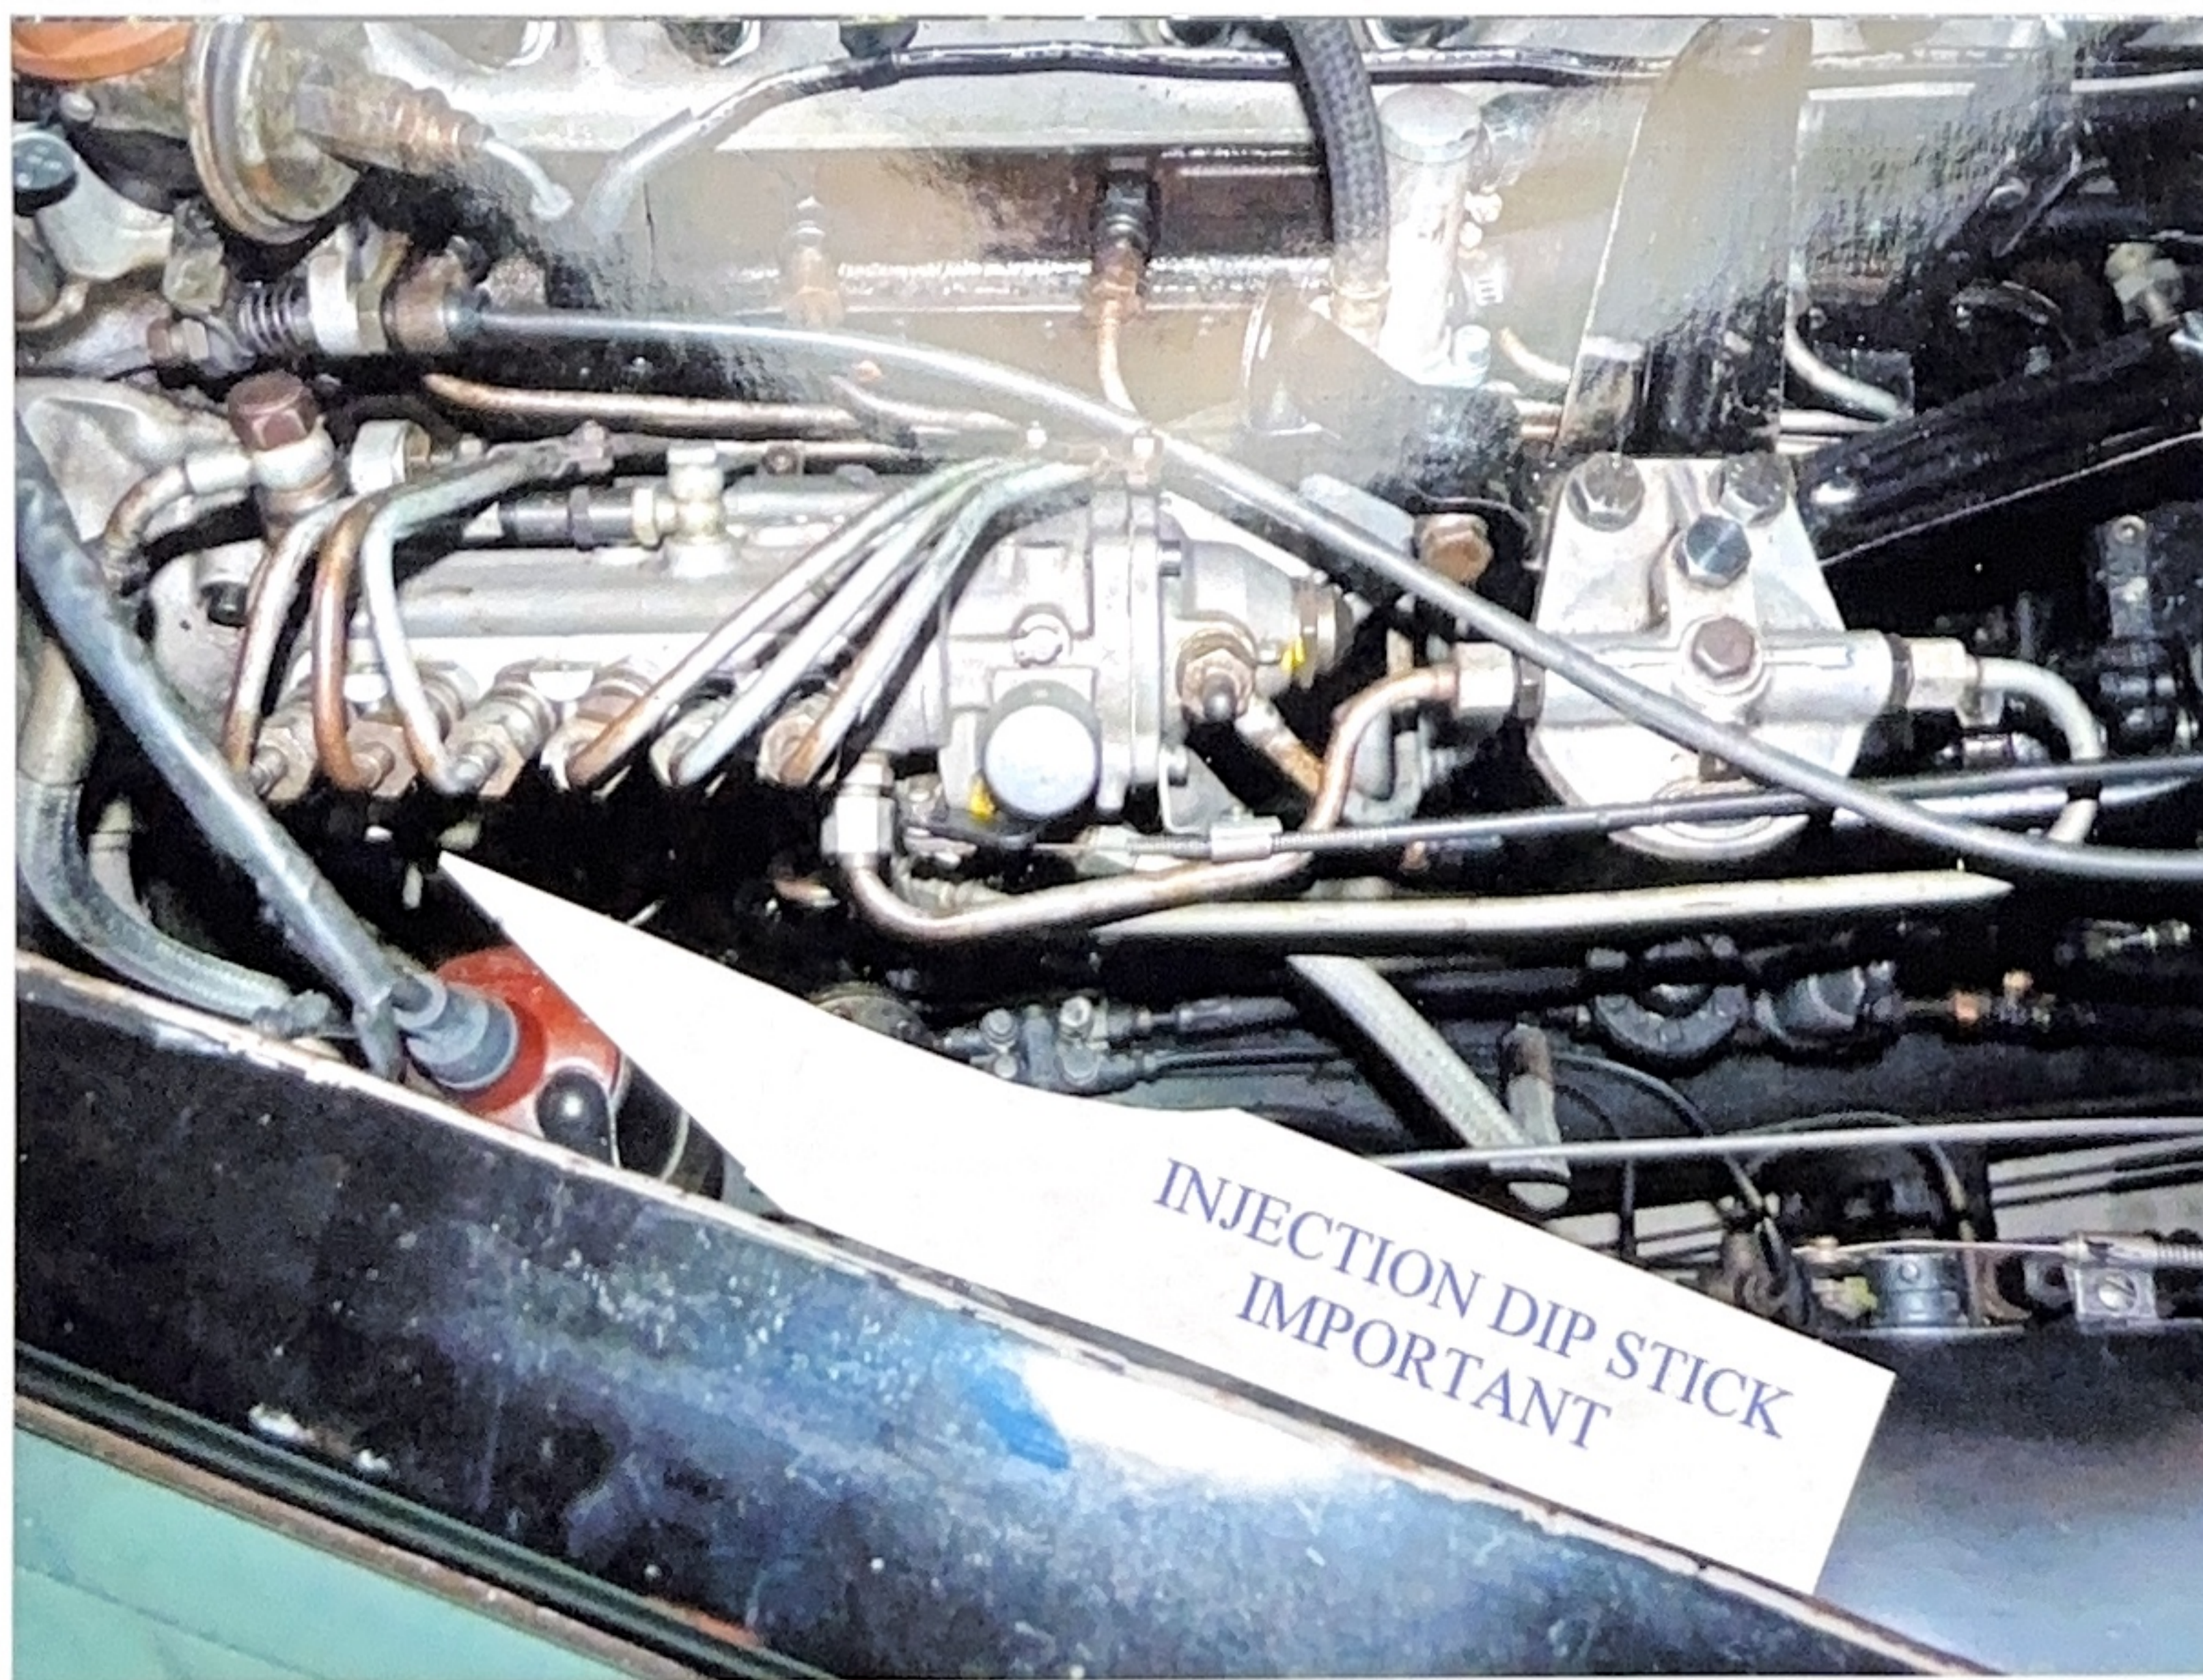
ScC Injection System- Gearbox-Clutch

In 2015, I experienced gearbox occasionally coming out of 3rd gear upon deceleration.... No wear whatsoever but excessive main shaft 3/4 clearance.

Inspected clutch lining & pressure plate assembly at the time.

Replaced 3rd/4th syncro hub, syncro rings and bearing at that time.

Transmission mount replace and remote shift bushings replaced .

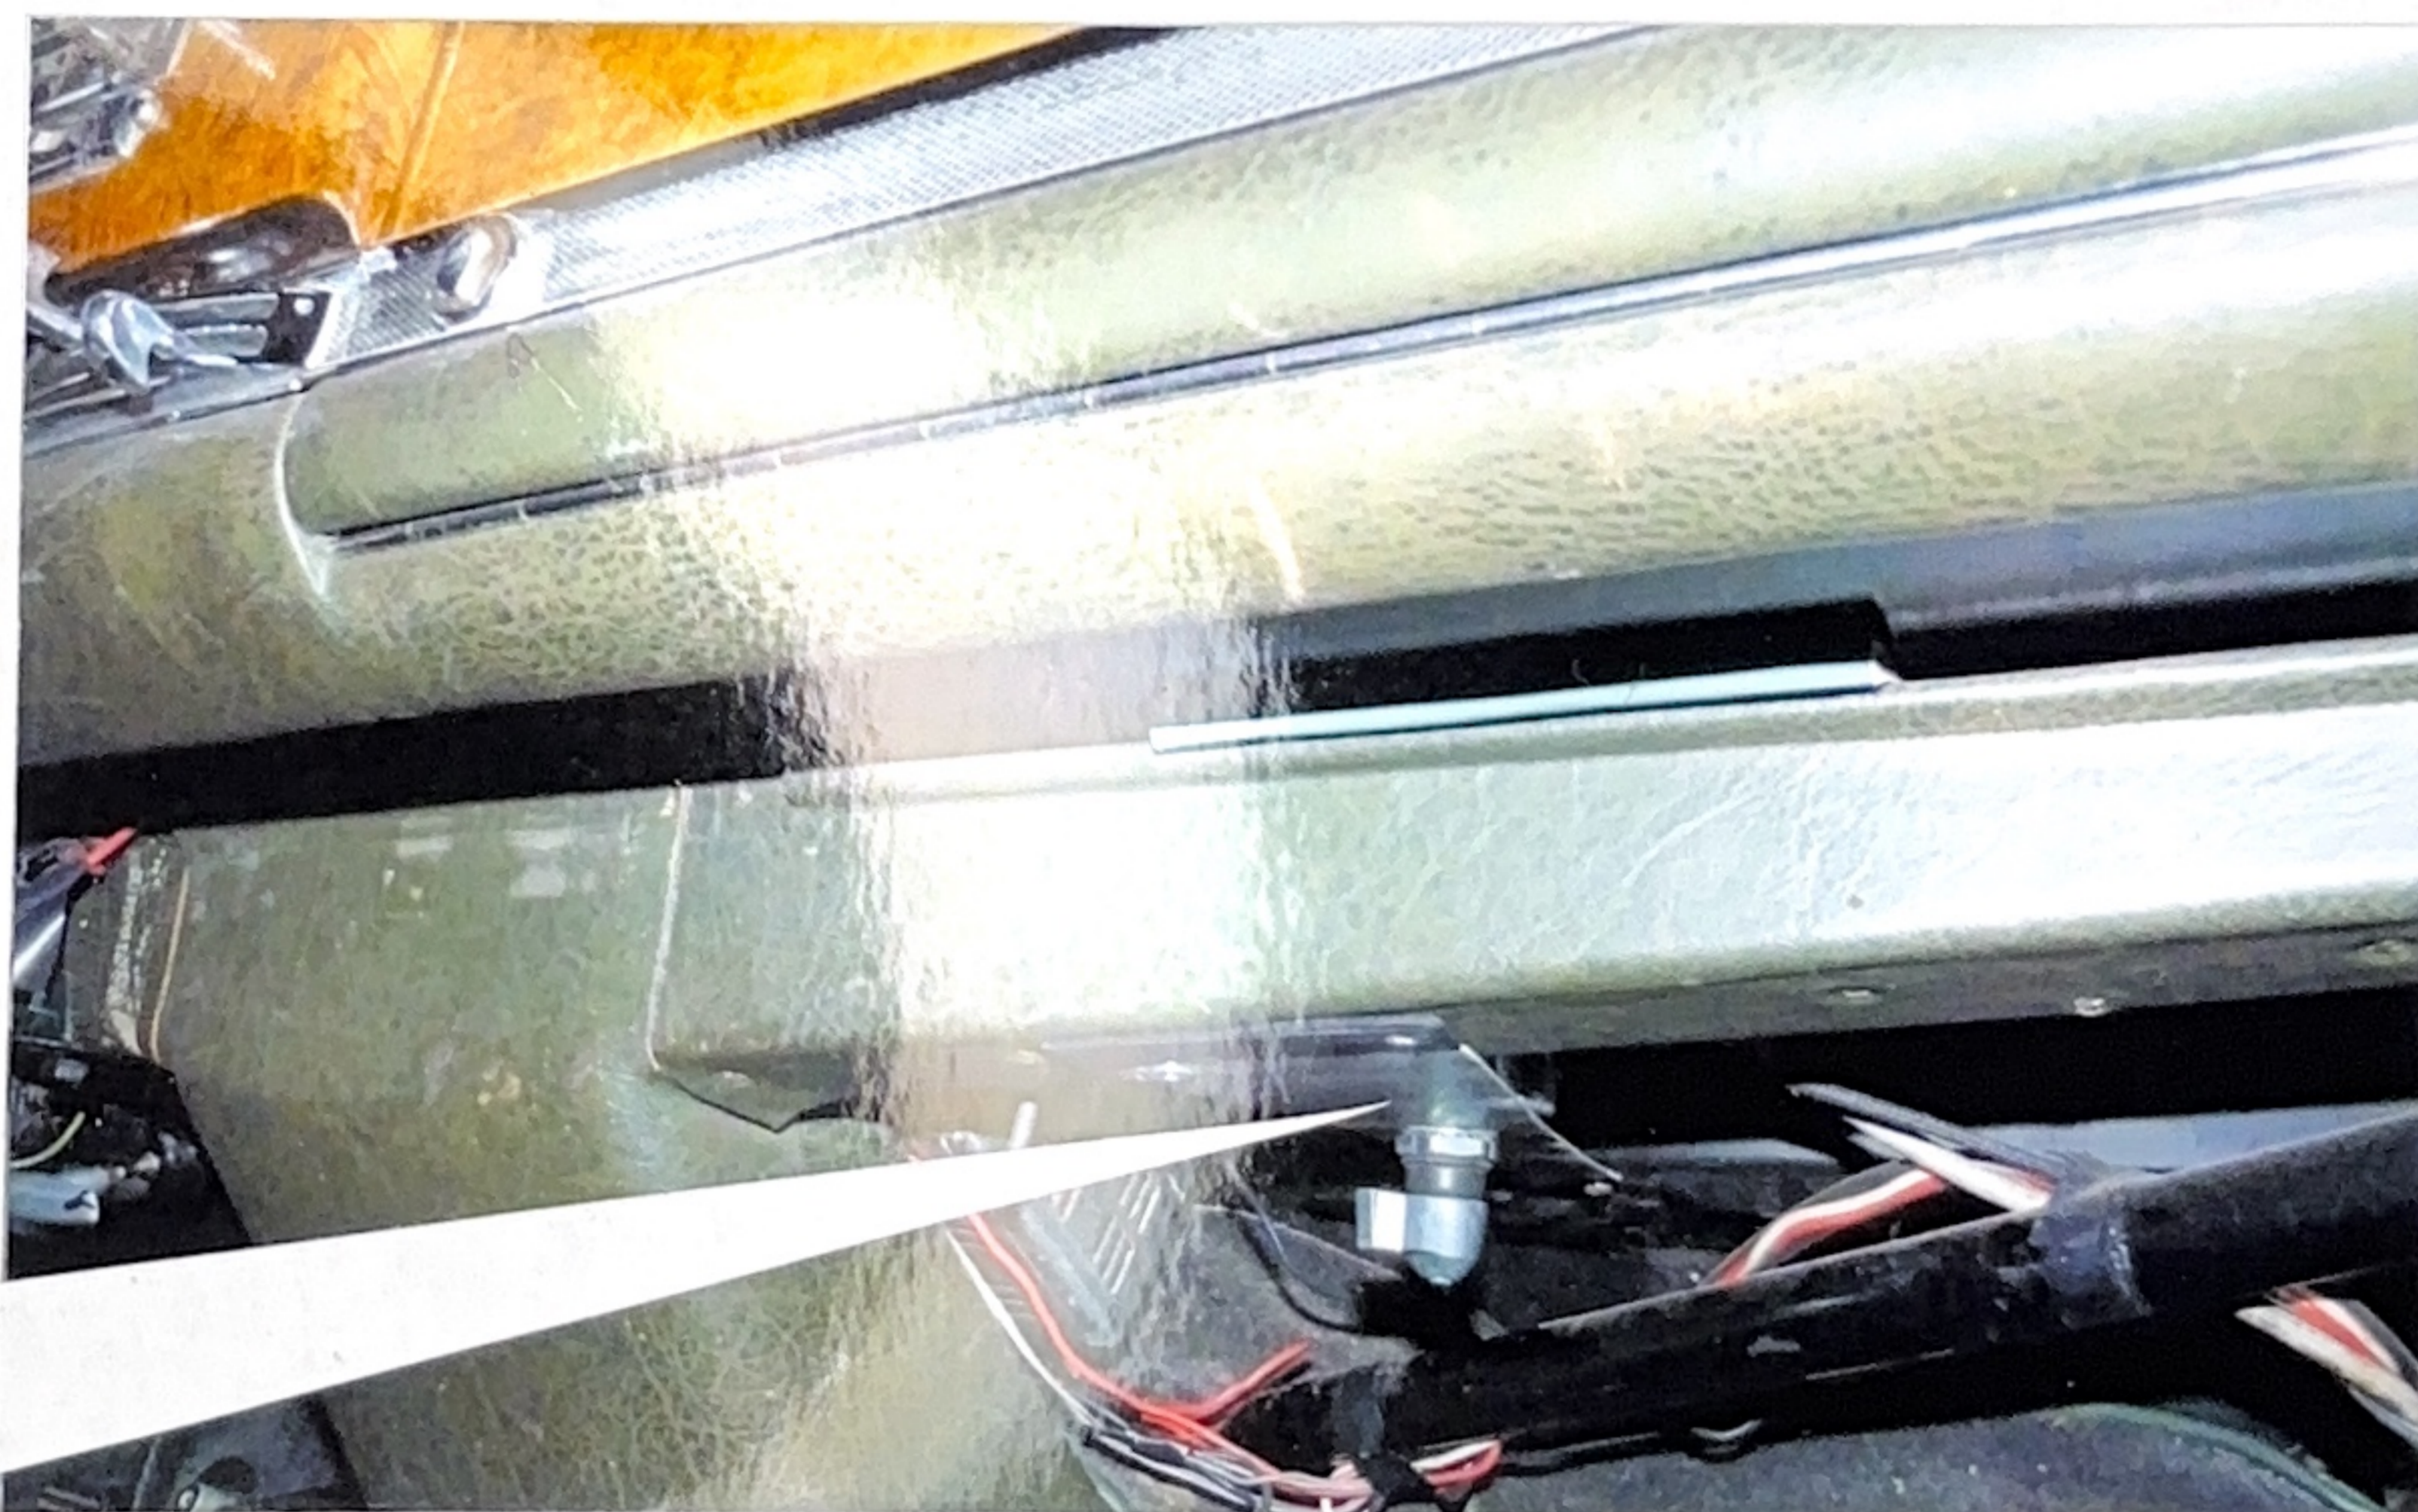
BATTERY GROUND
SWITCH

Battery ground isolator switch installed 1980's

Battery leads for maintenance charger fitted
under right front seat carpet.

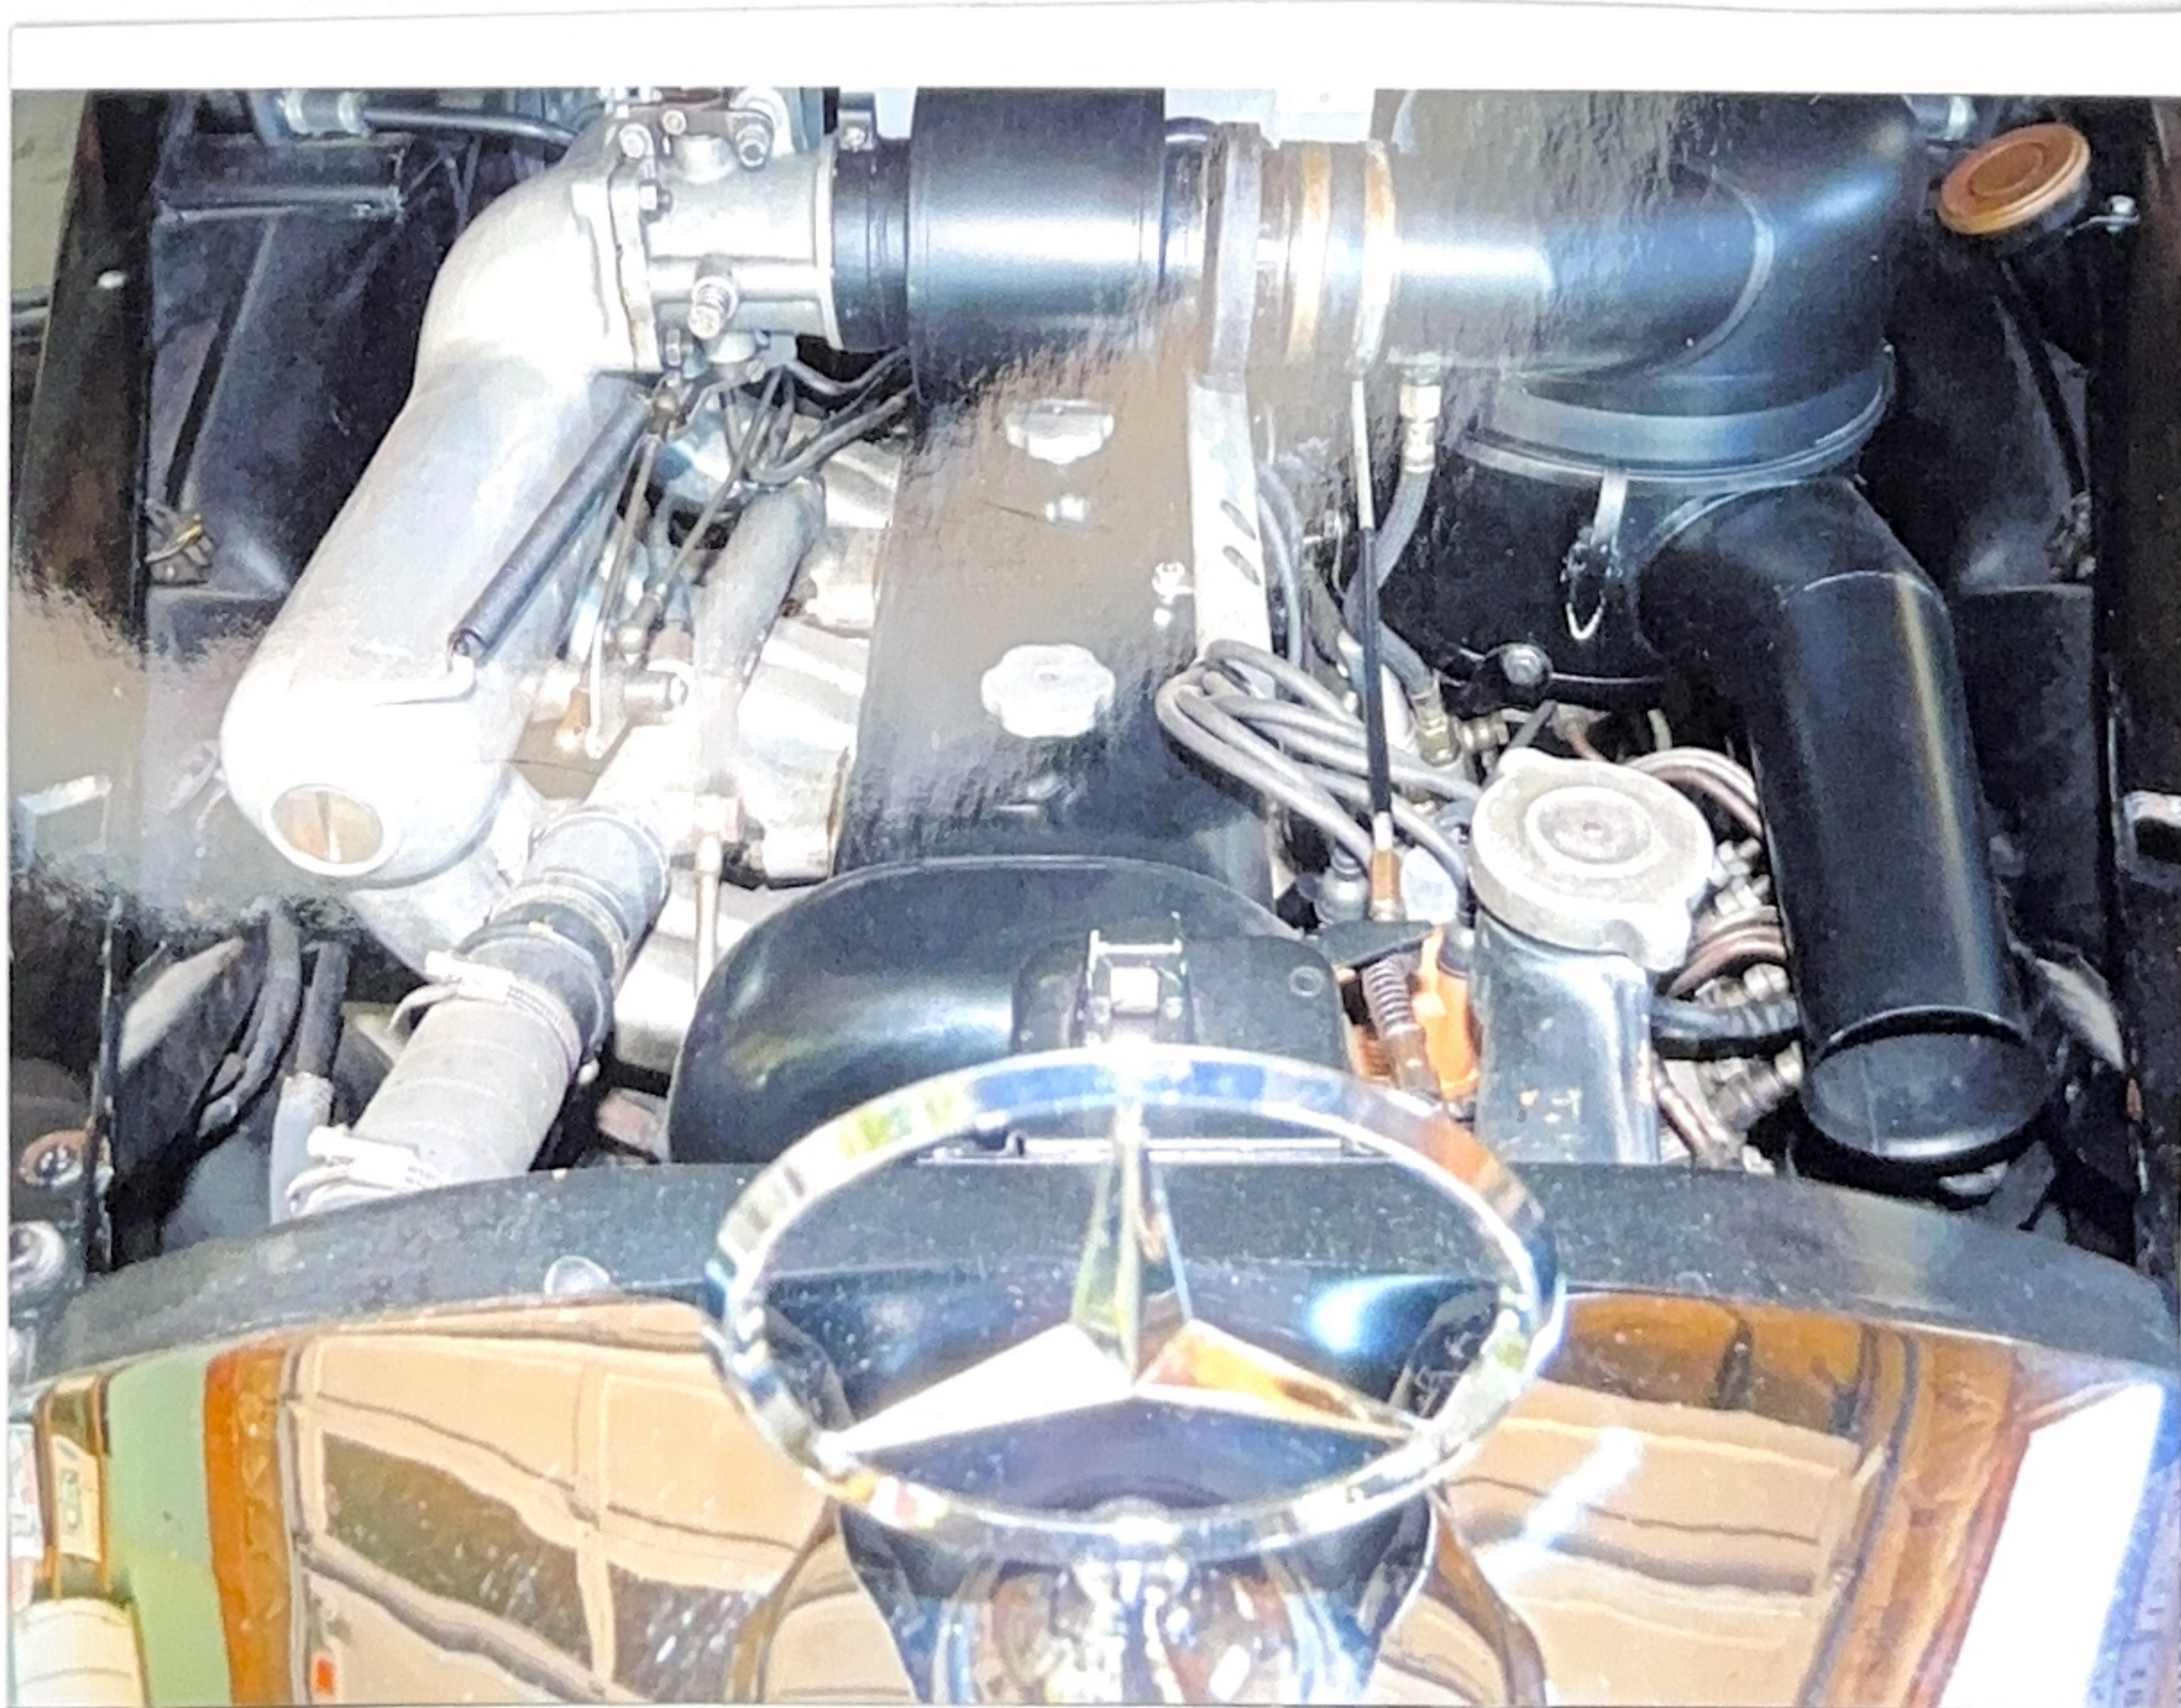
ScBB Engine Notes & Detail

Attached photos of engine room condition. No steam cleaning ever allowed
As this would destroy electrical wiring insulation and rubber parts over time.

Engine Mounts replaced 2009

Ceramic coating applied to engine side coolant jackets in 2005.

Engine to gauge oil pressure hose replaced 2001.

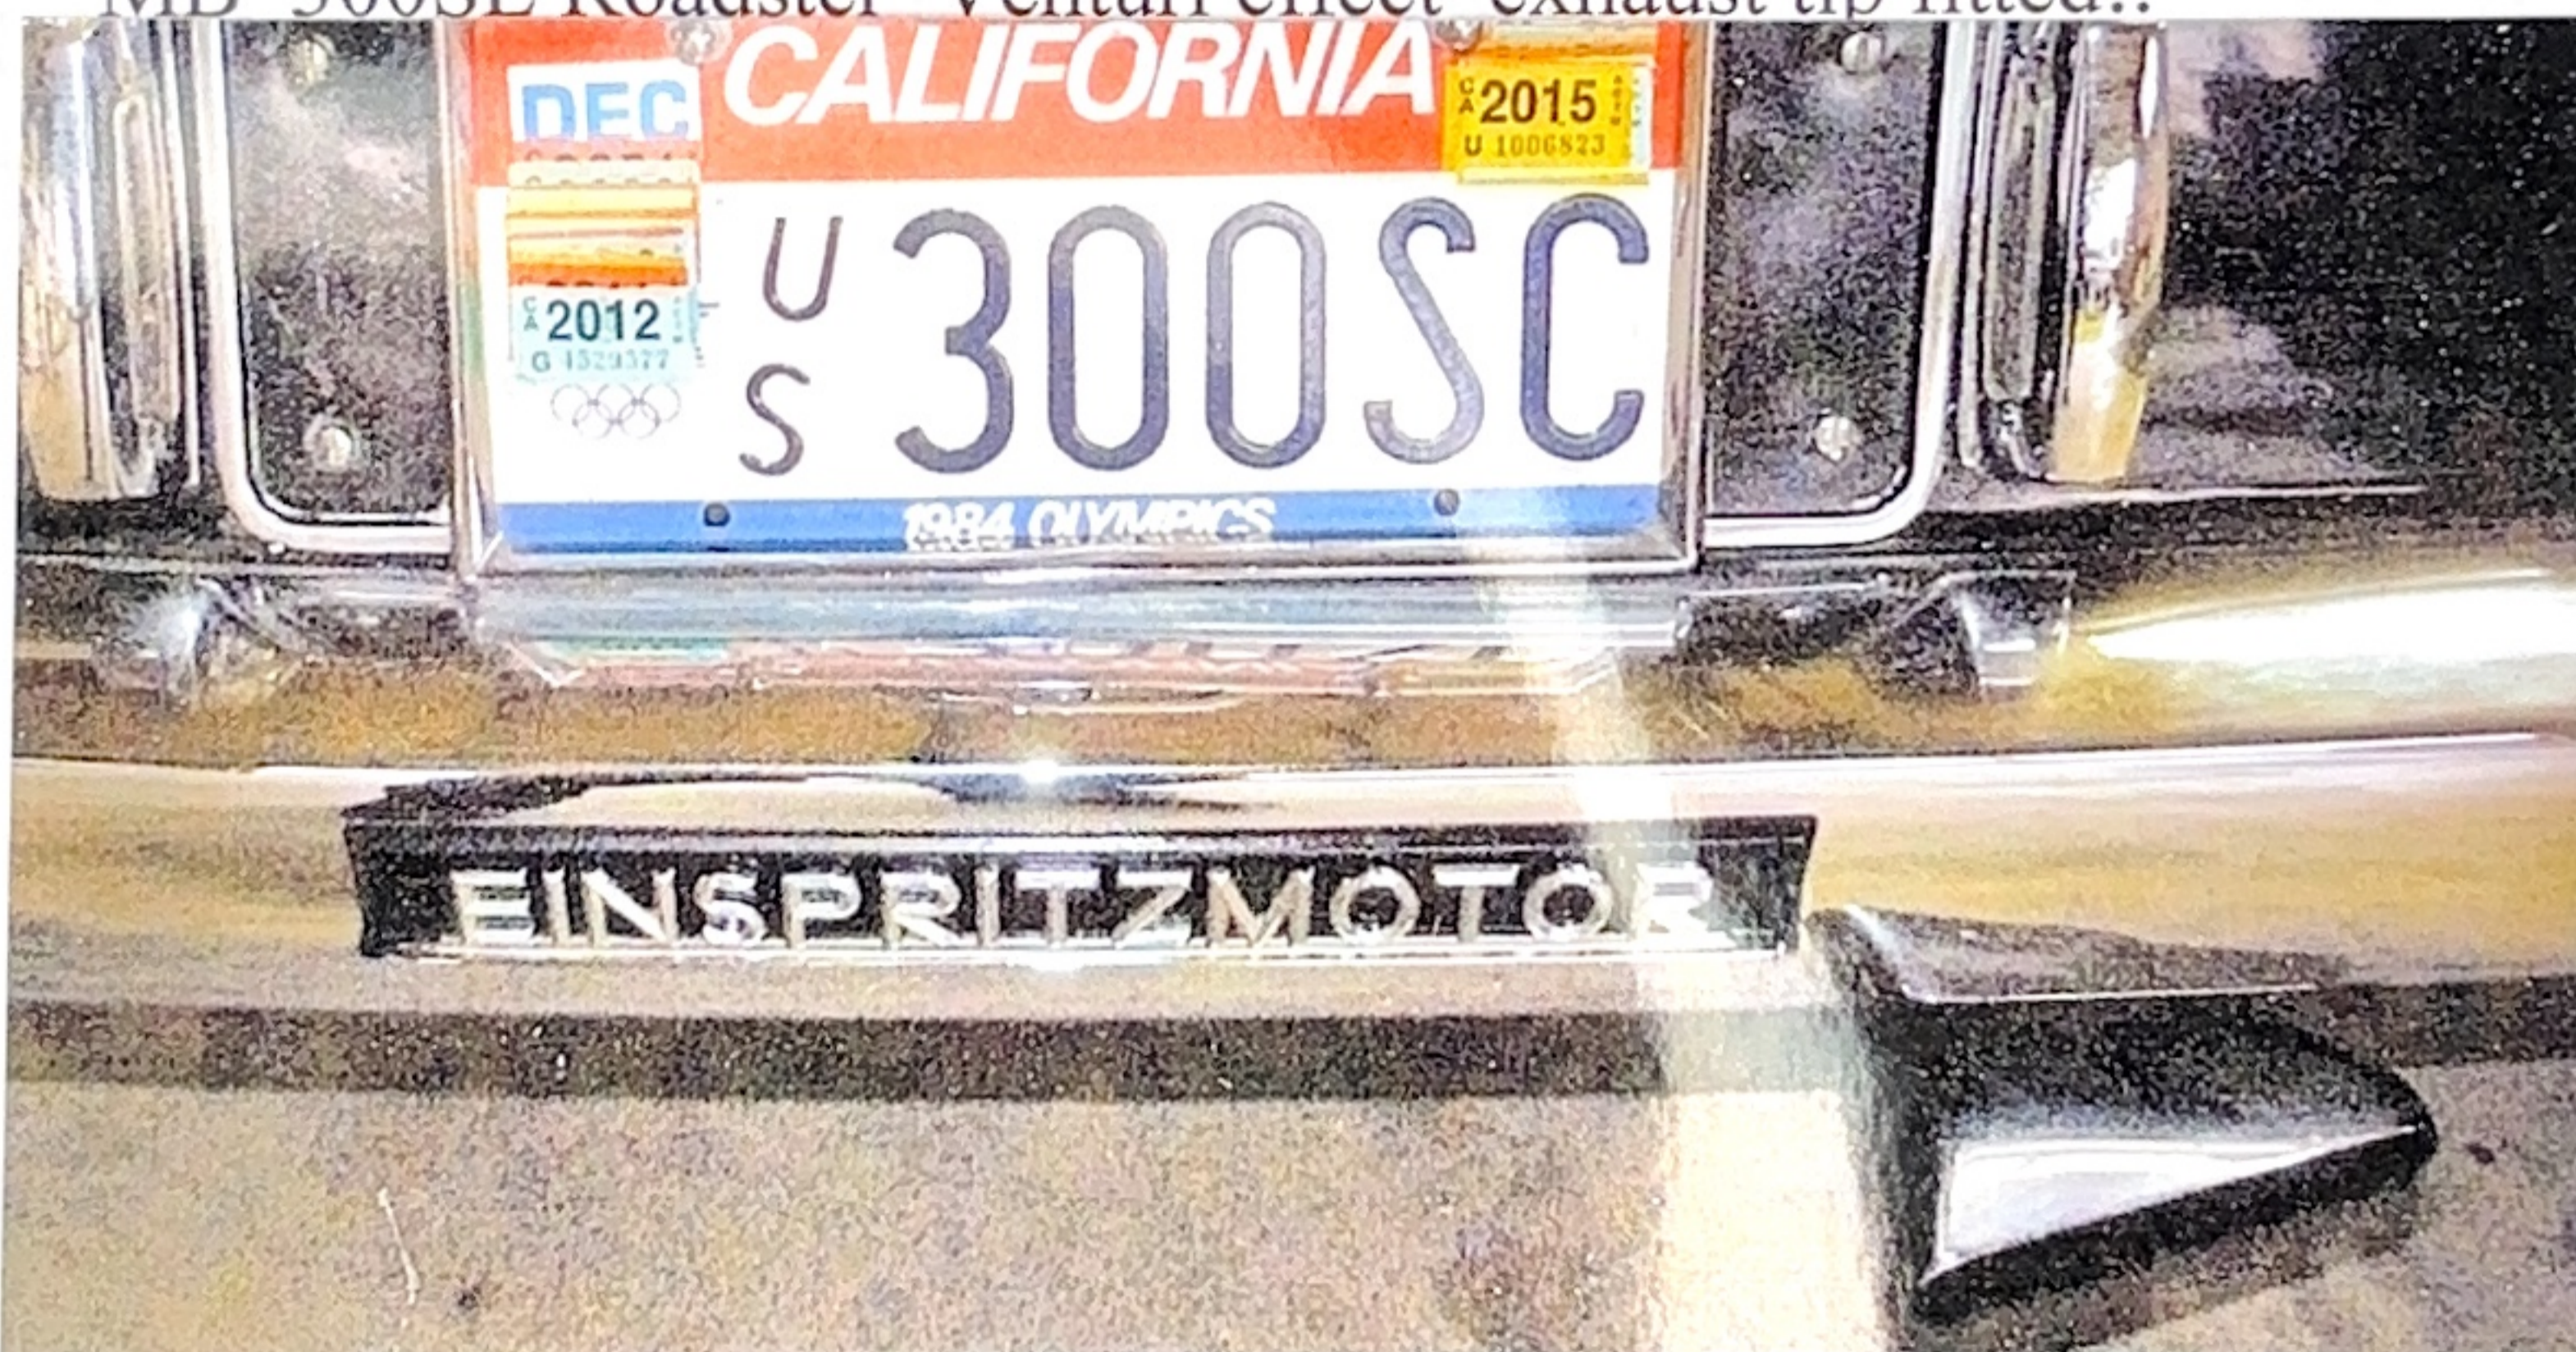
ScD Exhaust System

MB 300SL Roadster Venturi effect exhaust tip fitted!

In 2014 the entire exhaust system was removed and new factory mufflers with all mounts were installed.

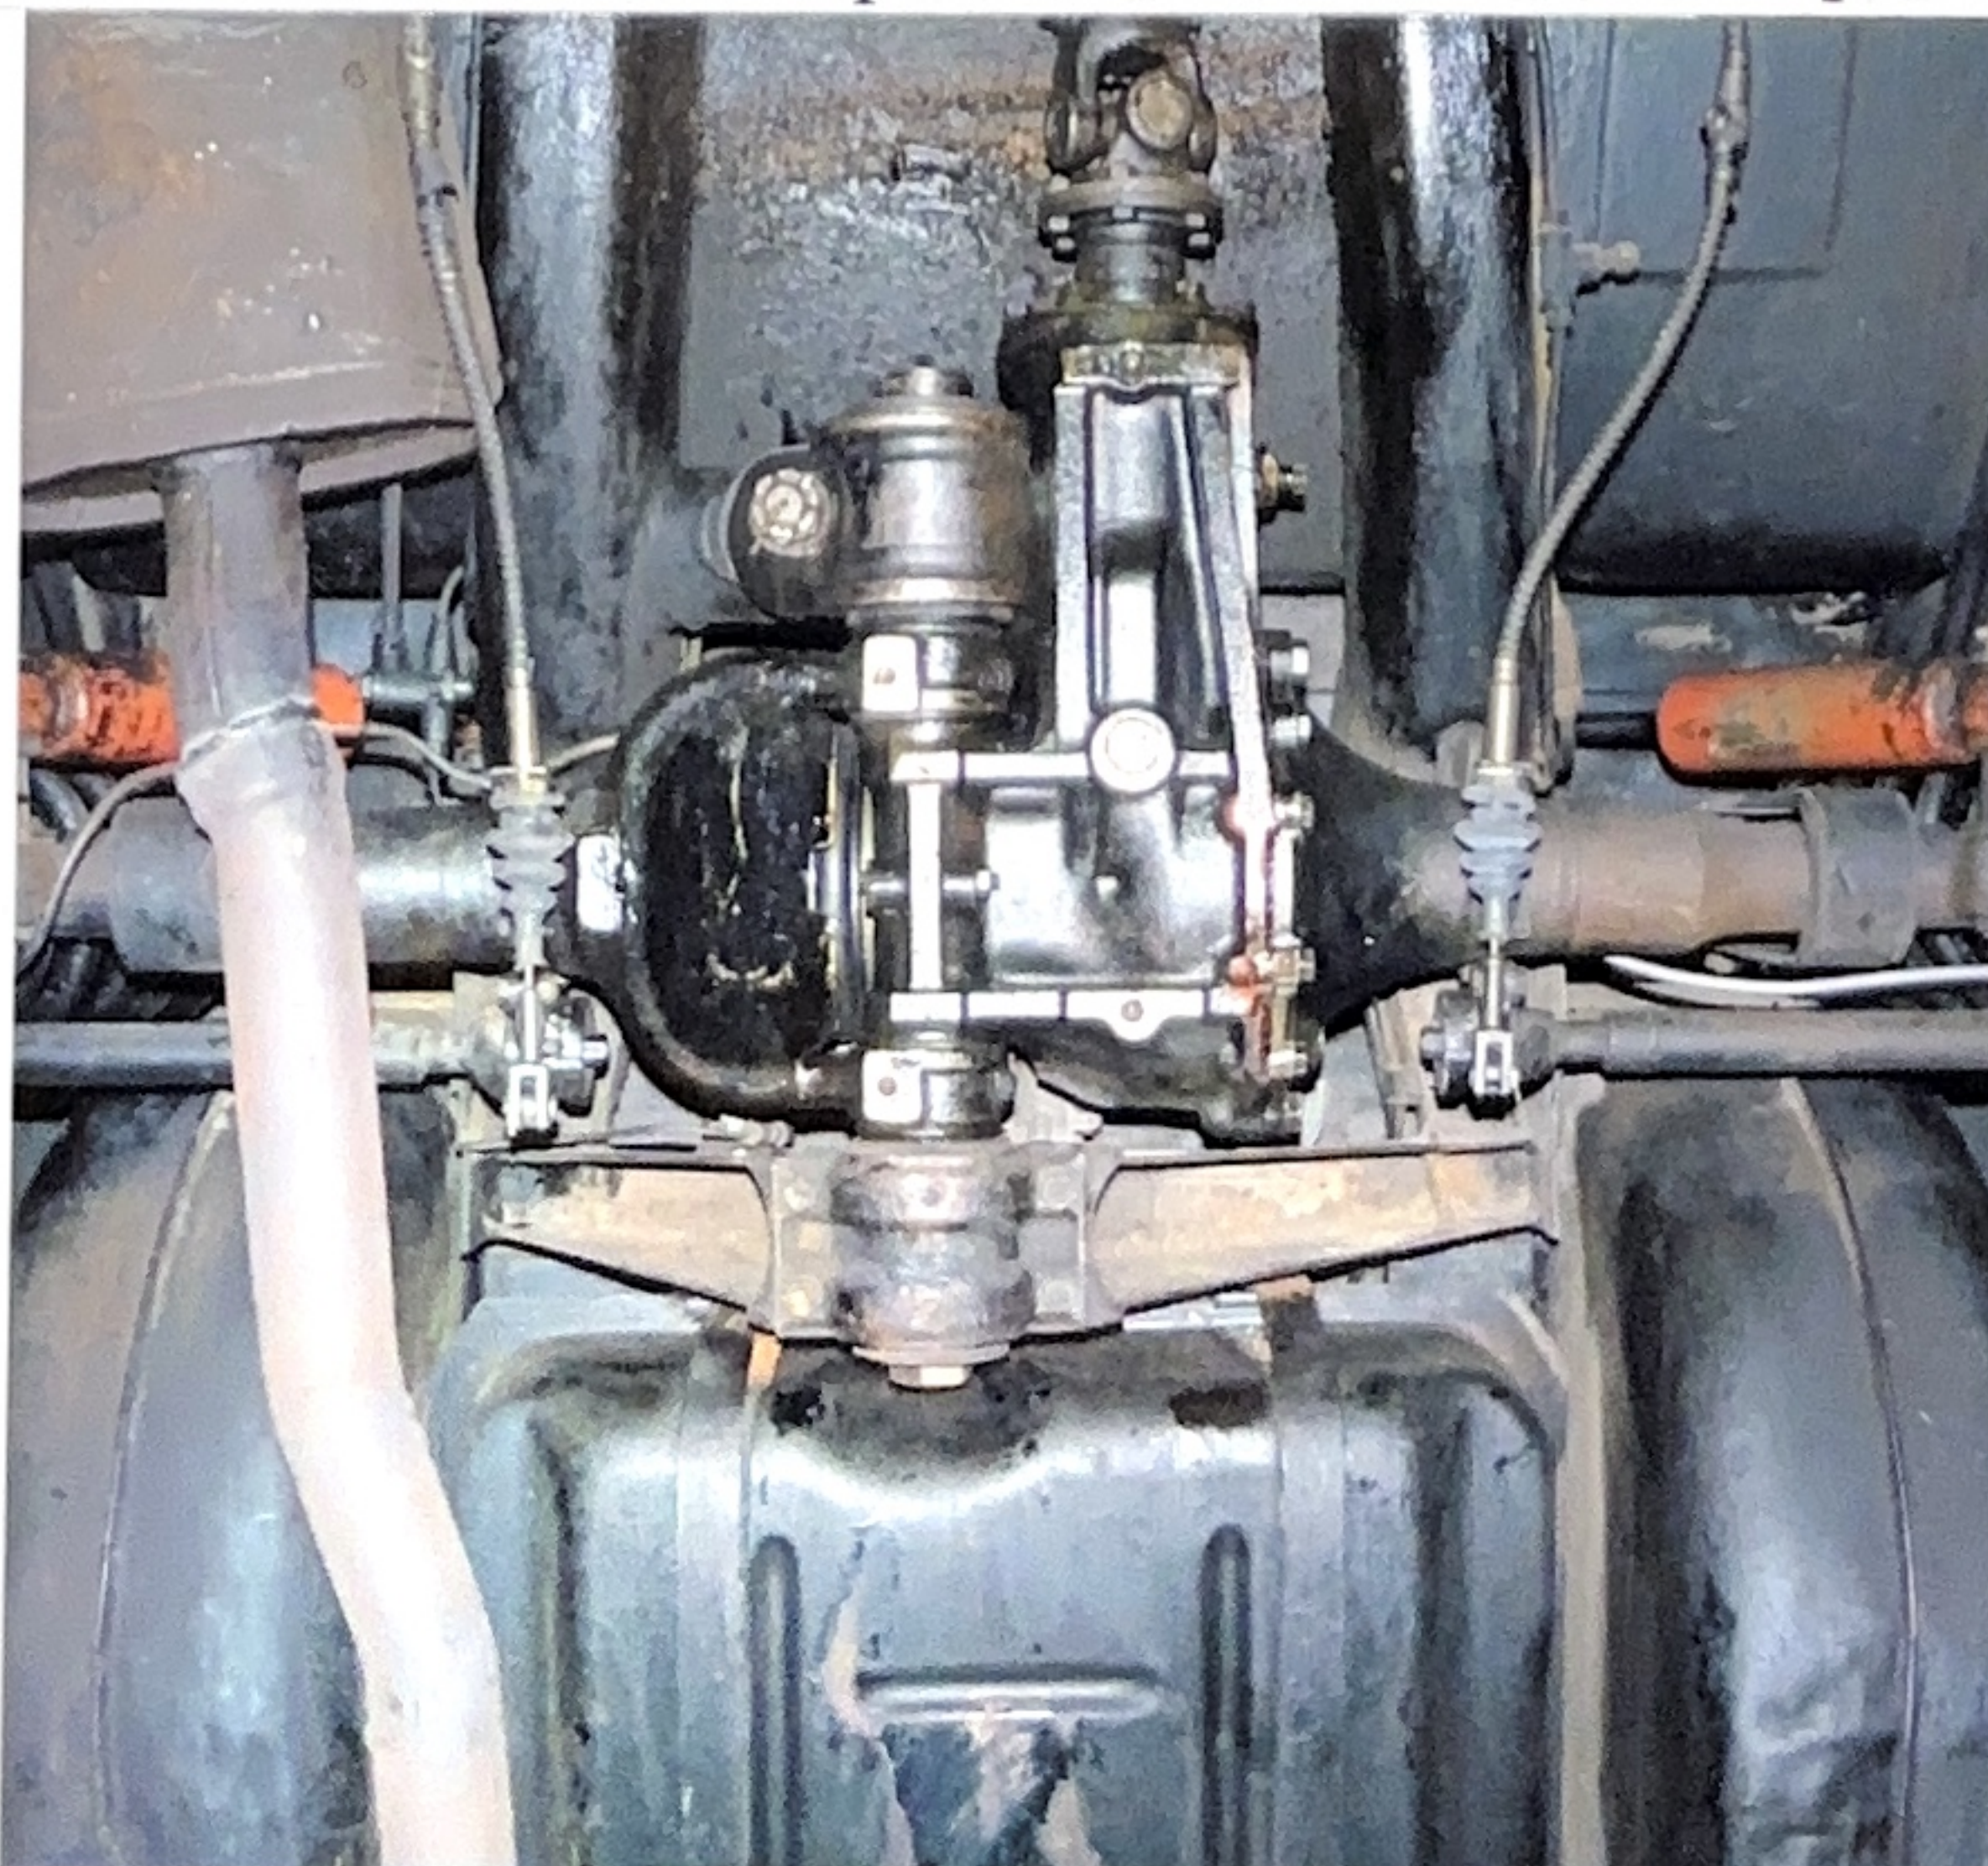
ScG Interior Detail

Original left hand outside mirror stored in rear seat compartment as a slightly larger mirror installed for safer driving.
(Photo Attached)

All leather, wool headliner, trim, golden burl wood, and chromium original. Some touchup of wood finish but no water separation of burl surface.(photos)

All instruments and controls inspected in 2015 found to be in perfect order as original at @ 83959 Kilometers (photos)

In about 1976 moths had damaged the original leather bound carpet. Replaced with German quality leather bound carpet at the time.

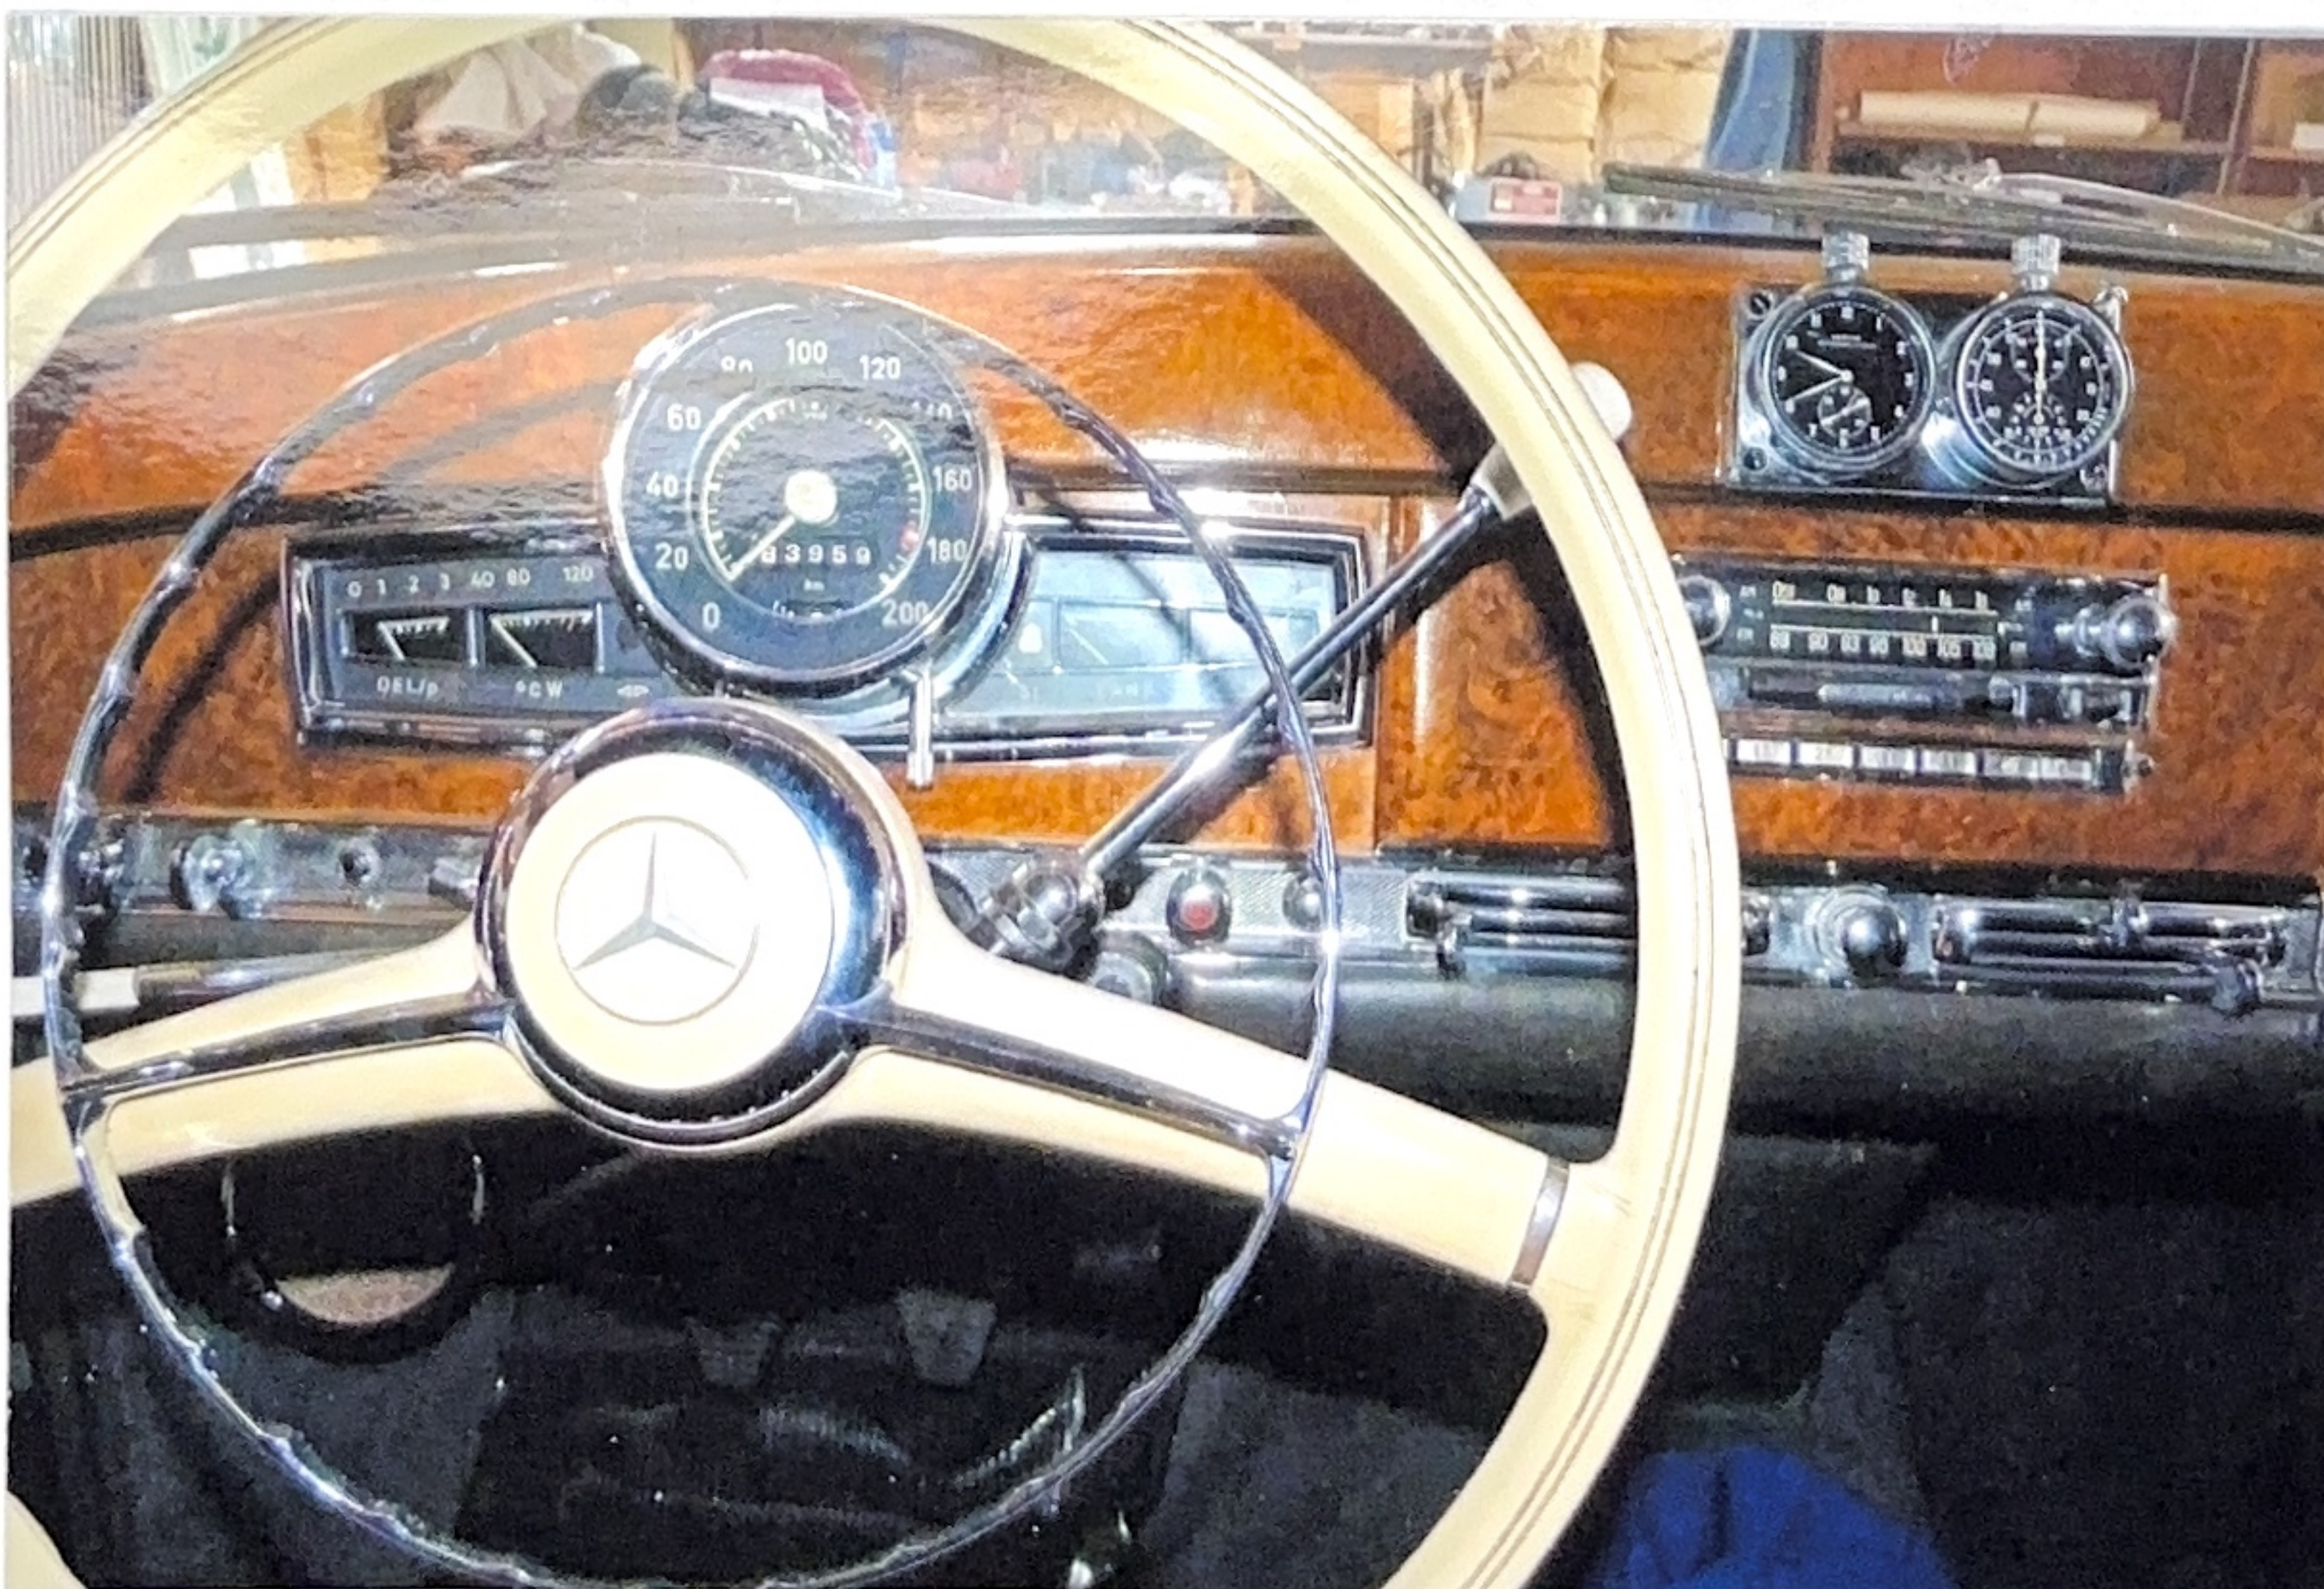
ScGG Trunk Detail

Original tan wool carpet still lines luggage compartment.

Complete tool kit still in place along with some special MB tools.

Original 4 piece "Pigskin" factory luggage fitted.

Shoe box is under Ladies hat box.....These would be removed in order to Carry a 2nd spare tire but seen in Europe in the 50's
