MAINTENANCE AND SERVICE NOTES

MERCEDES-BENZ 300Sc

MAINTENANCE AND SERVICE NOTES OF A LIFETIME ENJOYING THE 1956 MERCEDES-BENZ 300SC CABRIOLET

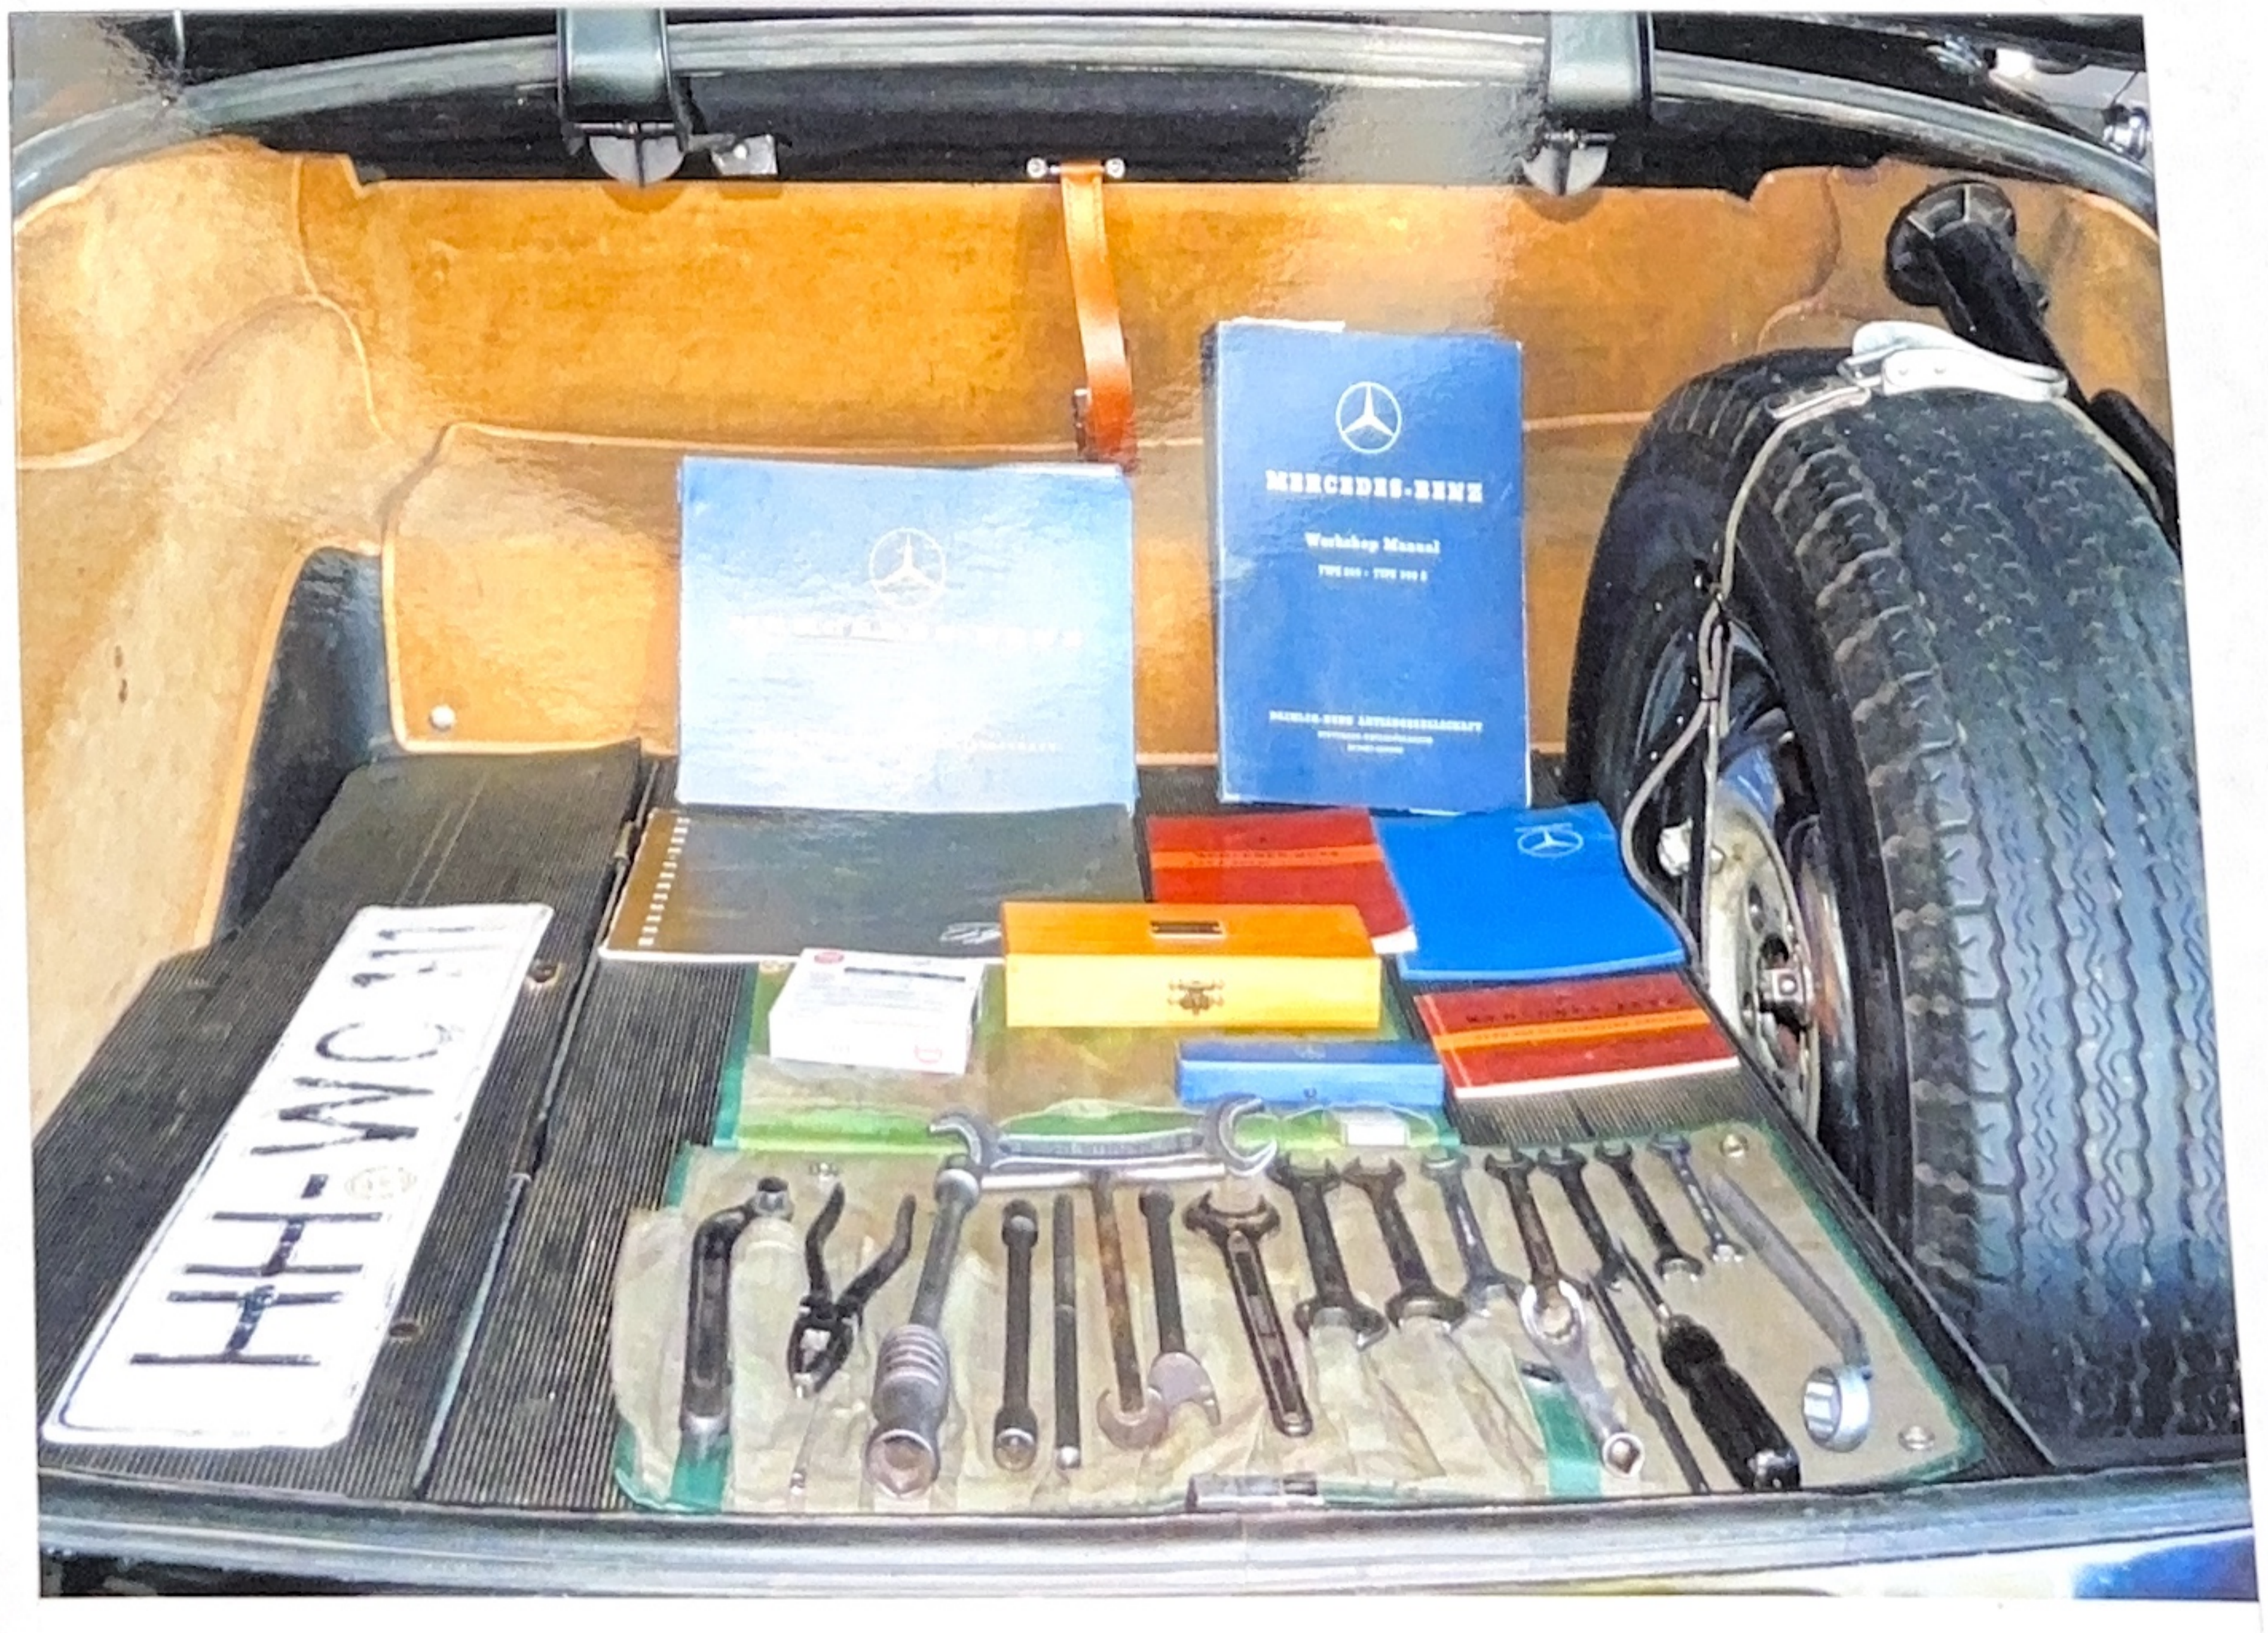
ScJ Body

The 92mm ridged Mercedes Star was fitted as German Law soon required the use of a fold down star. Note lock sleeve pin to secure assembly! Photo attached.

NOT OPERATED WINTER MONTHS GERMANY or INDIANA
Rust free Body and Frame
Recent under side photos!

Prior to the 100th Anniversary of the Automobile Pebble Beach invitation in 1986, small chips and scratches were refinished to the original DB 40H Black Nitrolac paint.

At about the same time German factory black canvas top material was fitted. Inspection proved all padding and flawless wool headliner to be in fine condition.
New Landau iron support rubber boots fitted in 2003,
